Long-term Exposure of PMA Conduits to Weathering

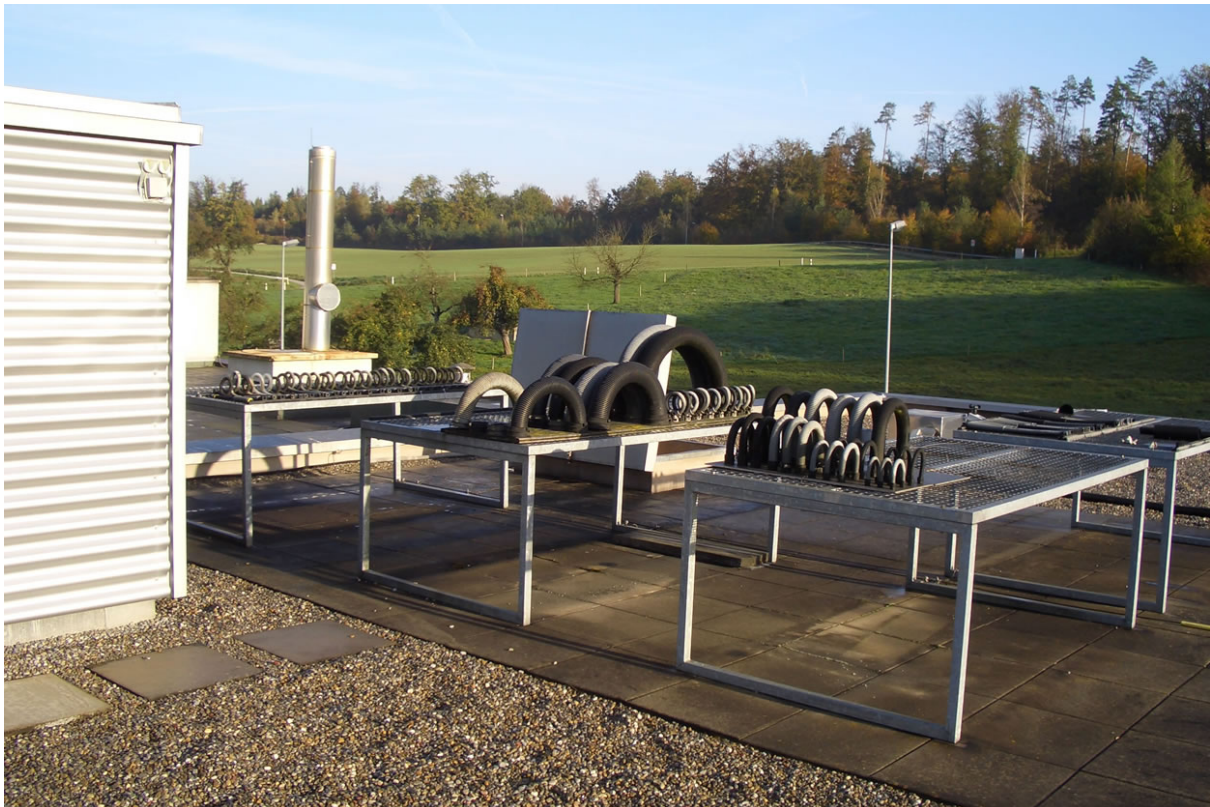
In addition to various accelerated test procedures, such as Xenon Arc UV radiation testing PMA has had a long-term weathering test running on the roof of their manufacturing facilities for over twenty five years now.

The following pictures show samples of various types of PMA polyamide conduit mounted on fixtures on the roof of the building. The deterioration of the wooden mounting plates themselves and the moss growing on them are an indication of the duration of exposure.

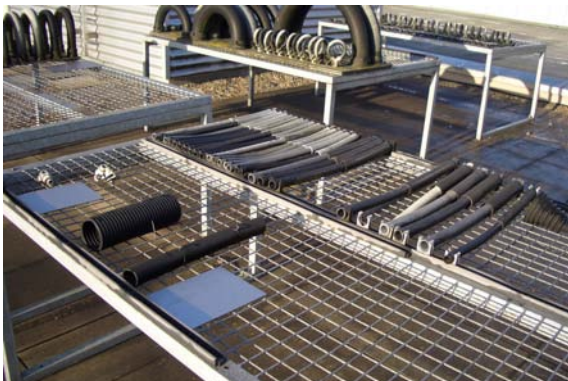
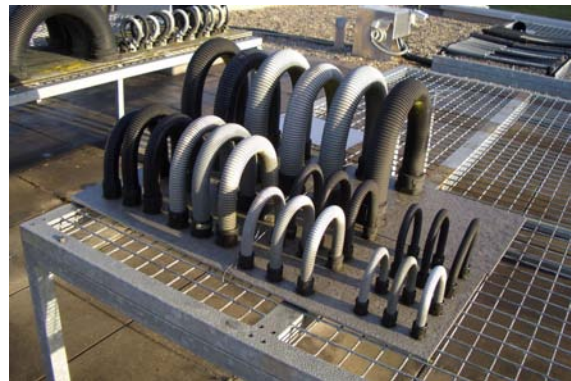
The samples on the wooden boards have been exposed to weathering for approx. 15 years.

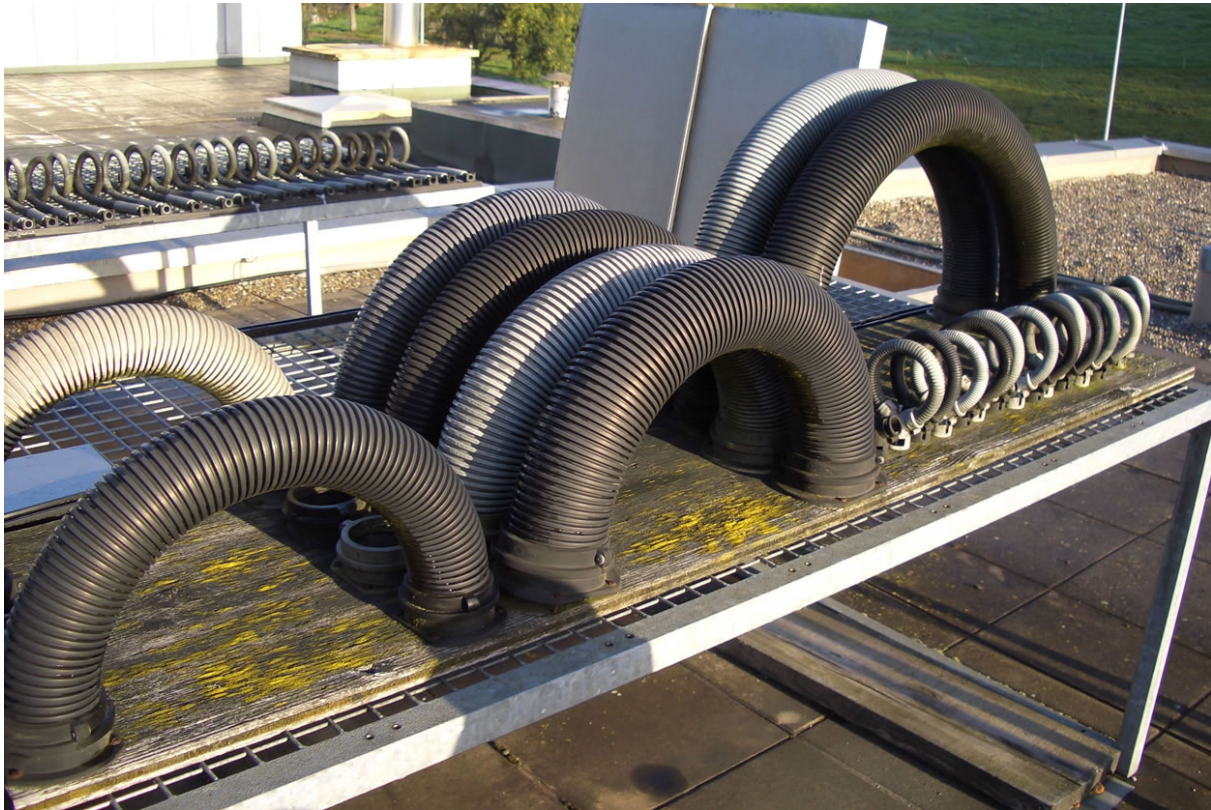
The other test specimens were also originally mounted on wooden boards but after more than 20 years of exposure to the elements the boards had deteriorated to such an extent that the product samples had to be remounted. The second time they were mounted on to a steel frame using clip.

A second larger diameter shorter piece of conduit is mounted on top of some test samples preventing exposure of a section of the specimens to weathering. This allows visual comparison of exposed and protected material.

The temperatures in Uster sink regularly to -10°C overnight in winter, -20°C on occasions and in summer >30°C is common. On the unprotected roof there is regular rainfall, often snow occasionally hail and up to 14 hours direct UV exposure in summer.

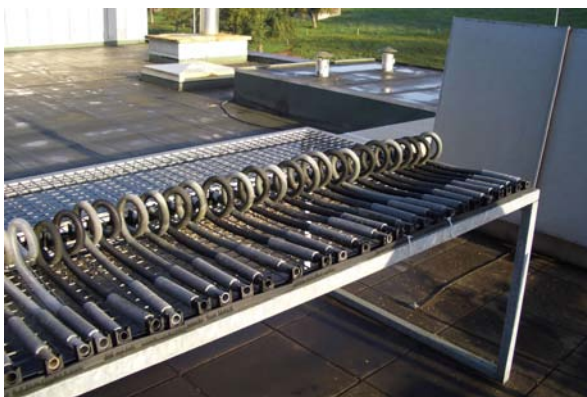
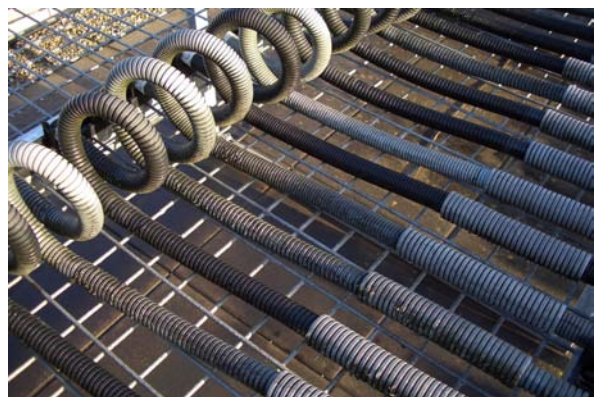
There is some discolouration of the Polyamide conduits visible, particularly the grey samples but no significant deterioration of the material has occurred.

PMA generally recommends black products for outdoor installation as they are less sensitive to UV. Also PA12 compounds are more resistant to weathering than PA6 based material. The specially modified PA12 conduits are in immaculate condition but even the PA6 types have resisted the years of exposure extremely well, showing only minor loss of gloss and colour on the surface.

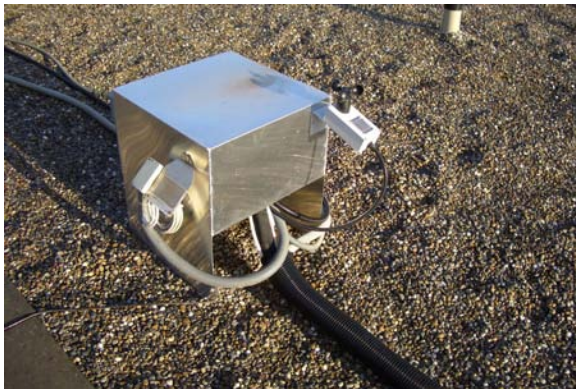
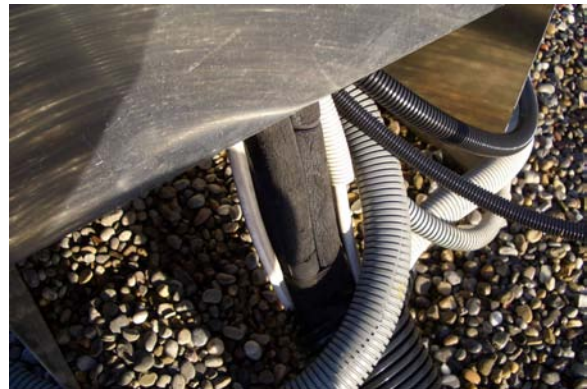
The next pictures show an electrical installation on the roof of the PMA building, it has been on the roof since the building was constructed in 1995. It's not part of the exposure test but the deterioration of the foam rubber insulation material illustrates what can happen to inappropriate plastic materials under the influence of weathering.
